MICROSTRUCTURE STUDIES OF REFRactory  
POLYCRYSTALLINE OXIDES

SUMMARY REPORT

9 March 1971 to 9 January 1972

AVCO CORPORATION  
Systems Division  
Lowell, Massachusetts 01851

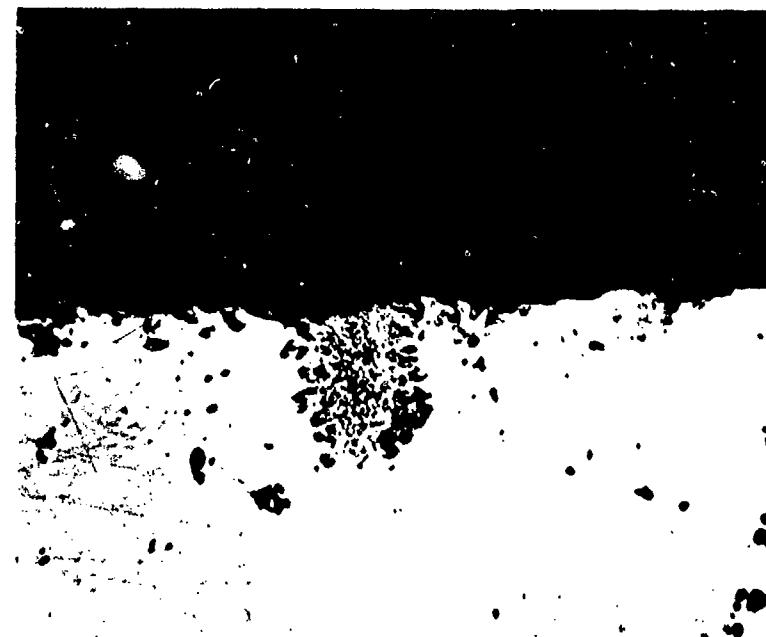
Billet 642 had a high incidence of oblong fine grained defects at the fracture origin. Figure 14a illustrates a macroscopic view of specimen 642-2. At higher magnifications, the fracture surface was indistinct, so the tensile surface was polished to intersect the flaw. Several specimens with similar flaws were polished before obtaining a suitable polish. Figure 14b illustrates the appearance of the flaw, and one is illustrated similar in appearance to that shown in Figure 14a. The area having the appearance of  $\frac{1}{2}$  of an oval is the flaw origin. The edge was difficult to prepare, thus it is uncertain whether or not the area was porous; there is a strong possibility that this is the case. Figure 15a is a polarized light photomicrograph of the same flaw shown in Figure 14b clearly outlining the extent of what can be identified as a second phase. Further evidence for a second phase is shown in Figure 15b where this area was lightly etched with phosphoric acid. The second phase zone has been selectively attacked leaving a few lightly etched grains of the second phase and a matrix that is virtually unetched. Thus the defect appears to have a chemical origin and is not related to the fine grain unbonded regions shown in Figure 8.

Figure 14. a) Fracture face in billet 642-2 of specimen having oblong flaw, and b) polished face normal to fracture face.

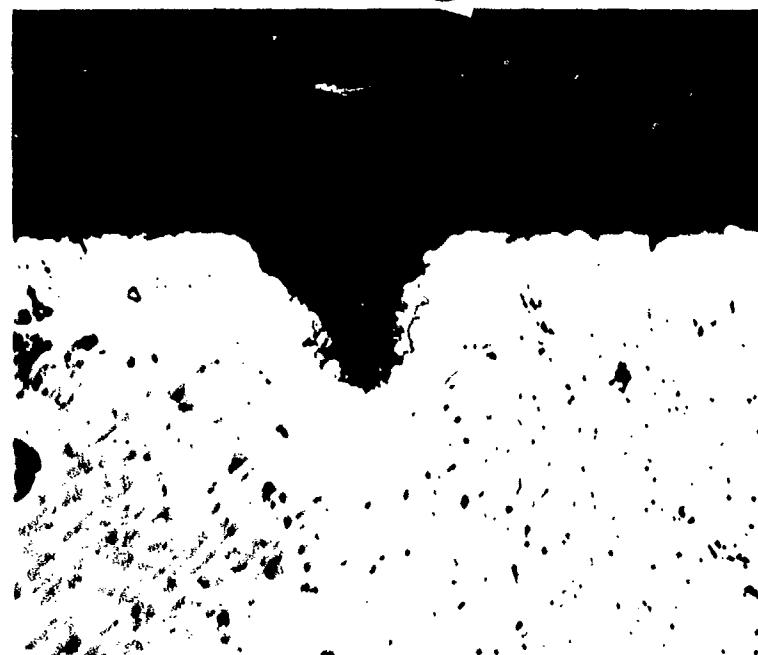
Figure 15. Section normal to fracture face on 642-oblong patch  
flaw viewed a) polarized light, and b) after light etch.

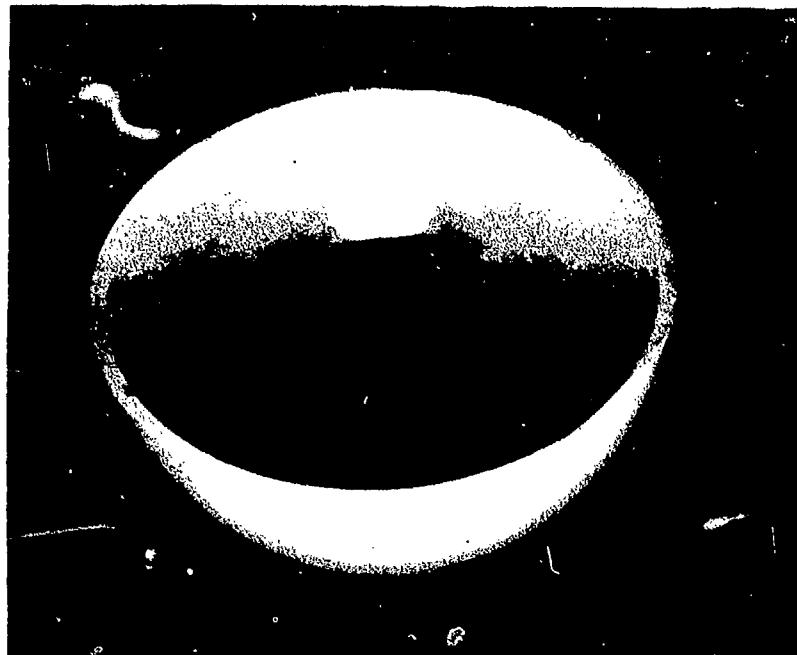
5551-1

Figure 18. Hemisphere 1577 Press Forged from Solid Right Cylinder.

time plot shown as Figure 20. The hemisphere exhibited a circumferential crack  $\frac{1}{4}$  inch in height from the apex. Radial cracks extend from this crack to the edge of the specimen. A second run was conducted at this higher strain rate to determine if the cracking was a result of deformation history or perhaps preform strength. At a point about 20 minutes into forging of 1666a, non-uniform deflection similar to that noted for 1613 was encountered. Since it was suspected that cracking had again occurred, the run was terminated after about 35 minutes. This served an additional purpose as plans had already been made to produce a partial forging to study the material flow characteristics. As expected, the piece was only partially forged and exhibited the circumferential crack in an identical position to sample 1613. The deflection-pressure-time plots shown as Figures 19 and 20 were carefully examined and compared. Deflection of between 0.210-0.350 inch occurred due to what is called "pumping action", where the hydraulic system is activated and controlled to give a prescribed deflection rate (0.030 to 0.050 inch/minute). After about 12 minutes of this, it was necessary to apply measurable load to continue forging. In run 1577, the initial deflection rate was 0.050 inch/minute and the load was kept at 2 tons for about 10 minutes while the piece deformed at a somewhat reduced rate of 0.020 inch/minute. As the deflection began to slow even further, the load was increased to 3, 5, and 10 tons keeping the deflection rate at about 0.020 inch/minute. On the other hand, run 1613 started off at a rate of about 0.030 inch/minute, was kept at 2 tons only for 2 minutes, and as the pressure was increased above 2 tons, the deflection rate sped up to almost 0.070 inch/minute. Based on similar deformation behavior and cracking for run 1666, it was thought that circumferential cracking occurred immediately after increasing the load above 2 tons due to exceeding the flow stress for the imposed temperature/strain rate/microstructure conditions. These runs effectively established an upper limit to the forging conditions for 94% dense preforms at 1885°C.
